HEART Claim Pics

Loss discovery photos

Inspection photos

Inspection on 2018-08-15 1814 Broadway St, Vallejo, Ca

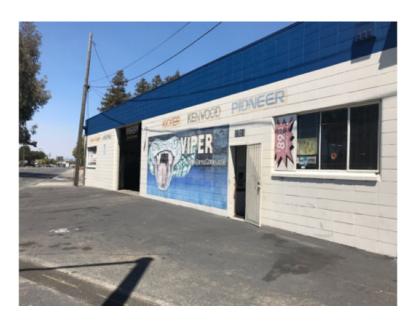
Risk shot

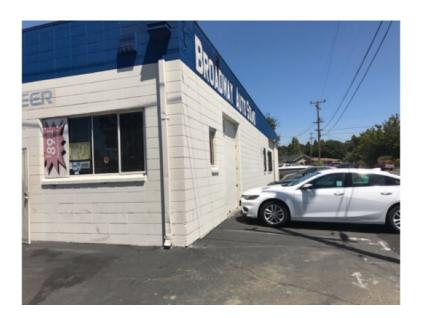
Right elevation

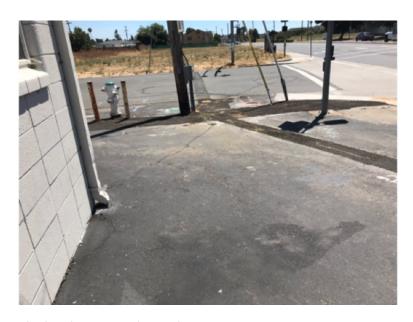
Area recently worked on by pge per insured

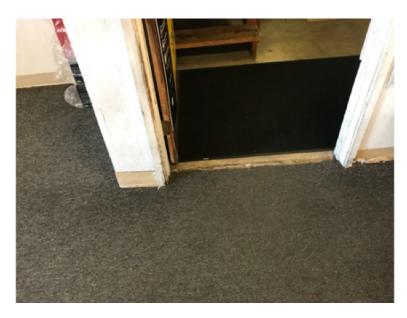
Entrance into garage from entry

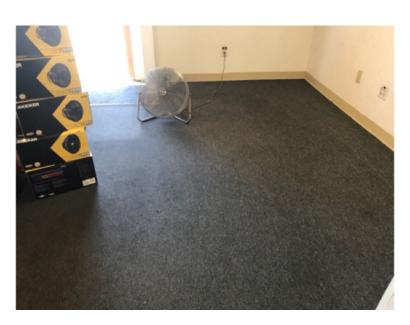
Fans placed for drying

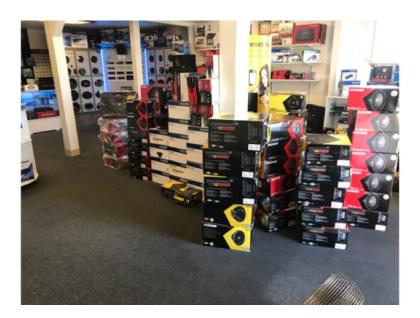
Inventory on floor

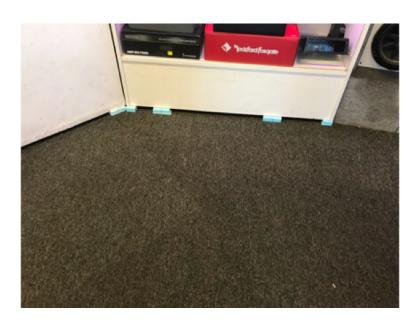
Display raised

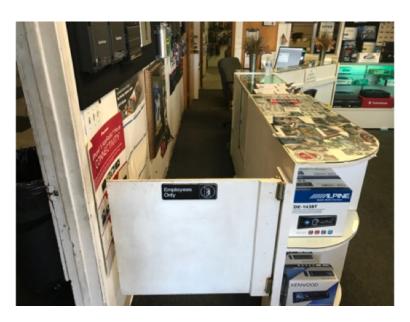
Ov towards Office

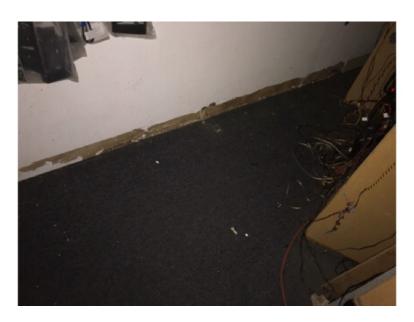
Base detached

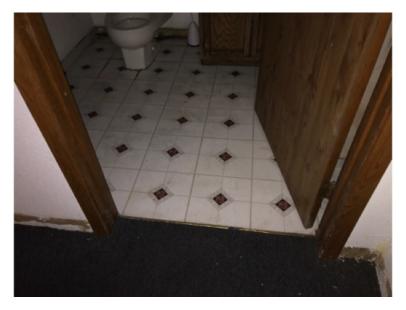
Ov entrance into bathroom

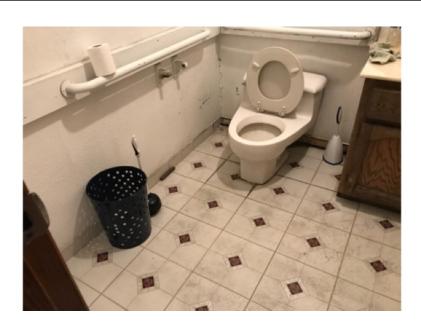
Floor wet at time of my inspection

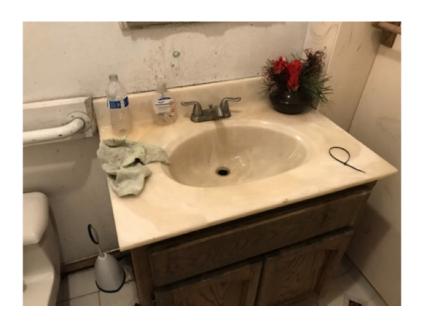
Staining indicative of pooled water

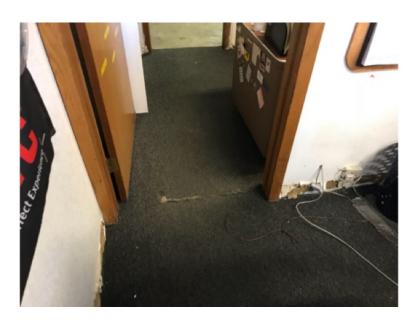
Overview towards office

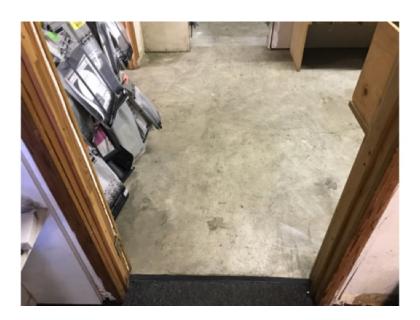
Overview towards storage area

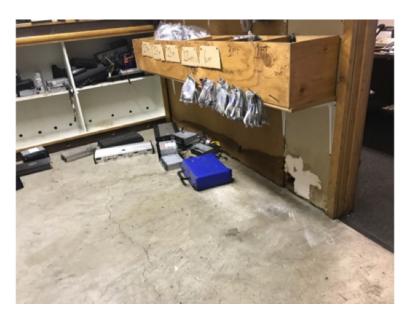
Water staining noted on wall

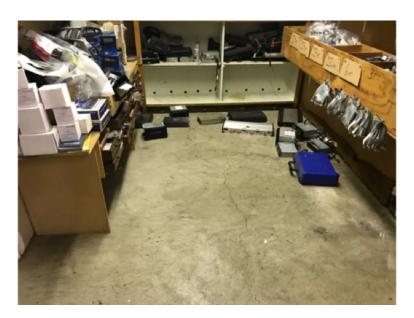
Overview of storage room

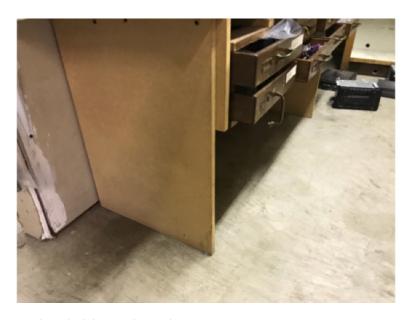
Water staining noted at shelving and panel

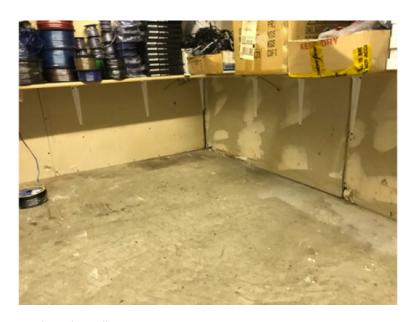
Water staining noted on drywall

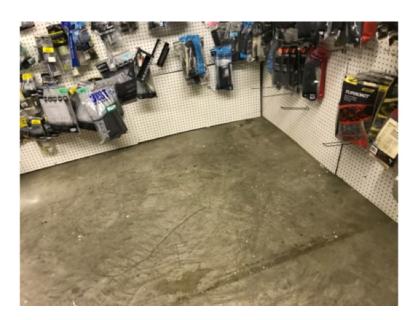
Continued overview

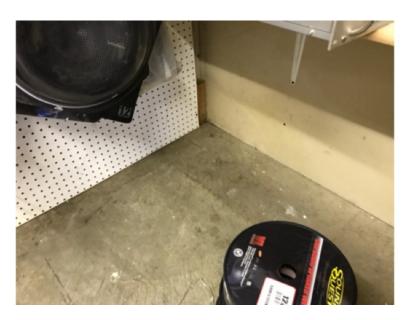
No water staining noted

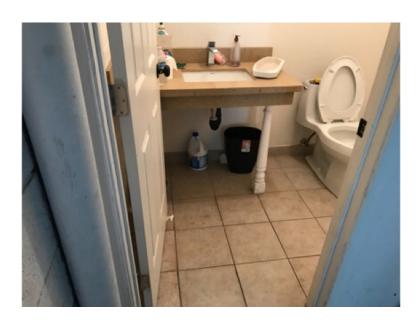
Ov bathroom two, at rear of building, Shares wall with bathroom one

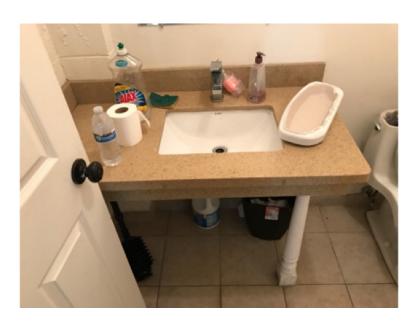
No evidence of pooled water in bathroom. Employee who came in the morning I've lost discovery noted water coming from the toilet

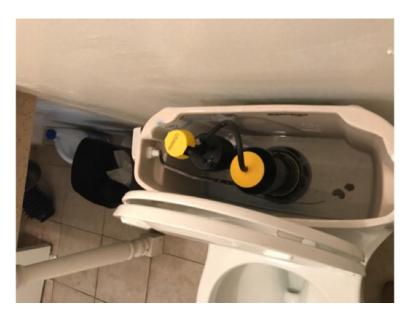
No evidence of damage

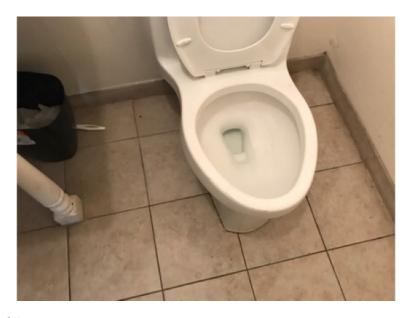
No evidence of damage

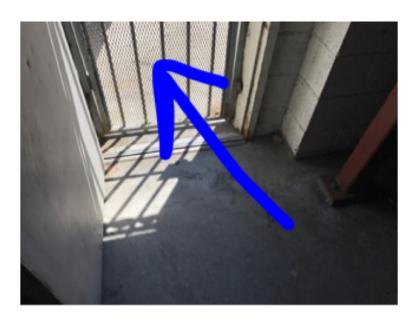
Overview of employee entrance door from which loss was discovered, water was streaming out

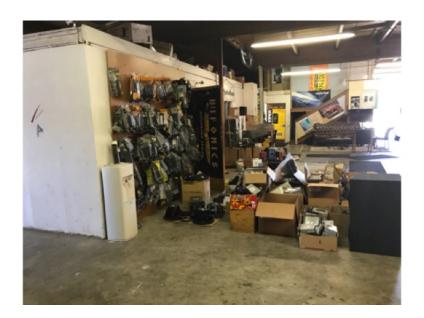
Damaged inventory

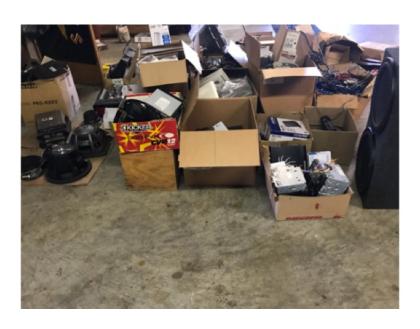
Staining along wall noted
